What is that Odour?

The Overlooked Problems of Soil, Waste
& Vent Systems in High Rise Buildings

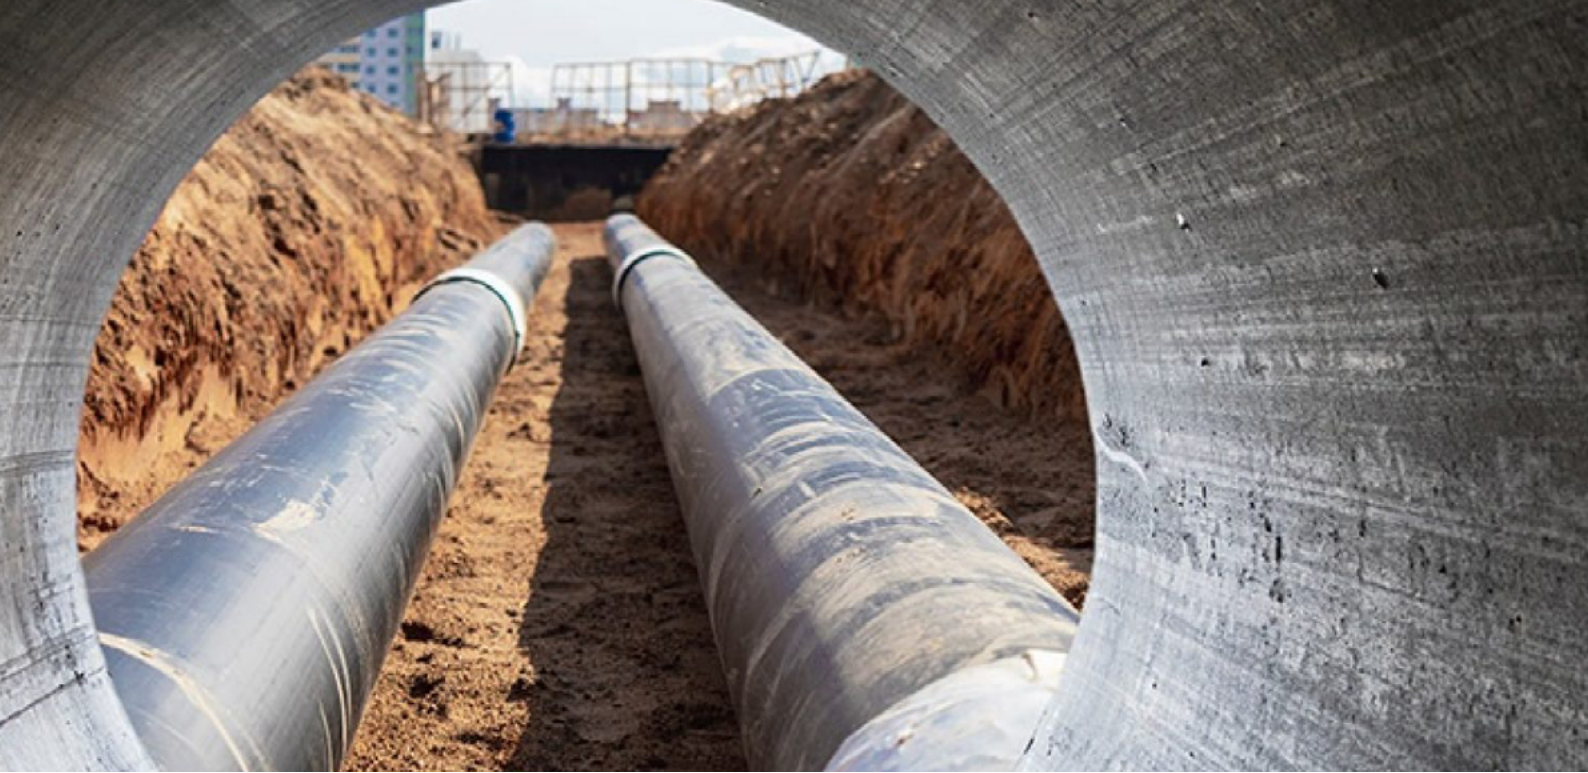
- **Induced-Siphonage** – This largely incorporates the same principals as Self Siphonage, but in this case it is caused by a large plug of water passing a branch connected to the same pipework as another trap/appliance. As the water passes the branch the suction effect is created again, without any air allowing the plug of water to be replaced a negative pressure is created down the adjacent branch, pulling the water out of the trap and leaving it dry and allowing bad odours to enter the space.

- **Compression** – Water and waste pressuring the stack, typically at the lowest point of the system, as water moves down a pipe in large volume, pressure builds! Without adequate ventilation to the pipe work by means of a dedicate vent pipe, that pressure tends to be released through the traps be it a floor drain, toilet, basin, sink, shower. This is known as the system “burping”. While the water in the trap may not be lost completely, the gaseous air pushes up through the trap and we experience that obnoxious smell. This can happen without any significant sound, leaving occupants to wonder where that awful odour is coming from.

- **Self-Siphonage** – Typically a common problem with sinks/basins and baths. Large volumes of water can be discharged fast and again, without the correct ventilation and or pipe level, water can fill the pipe completely and as it exits the waste pipe it pulls the trap seal (water) with it.

These are the 3 key causes of trap seal loss and they can generally be resolved at the design stage when the correct oversight is applied. Other issues our commissioning team look for are sizing of vent/stacks that exit buildings and installation details on drawing and actual installation in the field.
